REPORT NO.: T71468.01-01  
 WYLE JOB NO.: T71468.01  
 CLIENT P.O. NO.: PO325979  
 CONTRACT: N/A  
 TOTAL PAGES (INCLUDING COVER): 27  
 DATE: January 30, 2014

# TEST REPORT

## WITNESS OF TESTING FOR THE ELECTION SYSTEMS & SOFTWARE DS850 CENTRAL COUNT IN THE EVS 5.0.0.0 CERTIFIED CONFIGURATION

Oregon Secretary of State, Elections Division  
 255 Capitol St. NE, Suite 501  
 Salem, OR. 97310

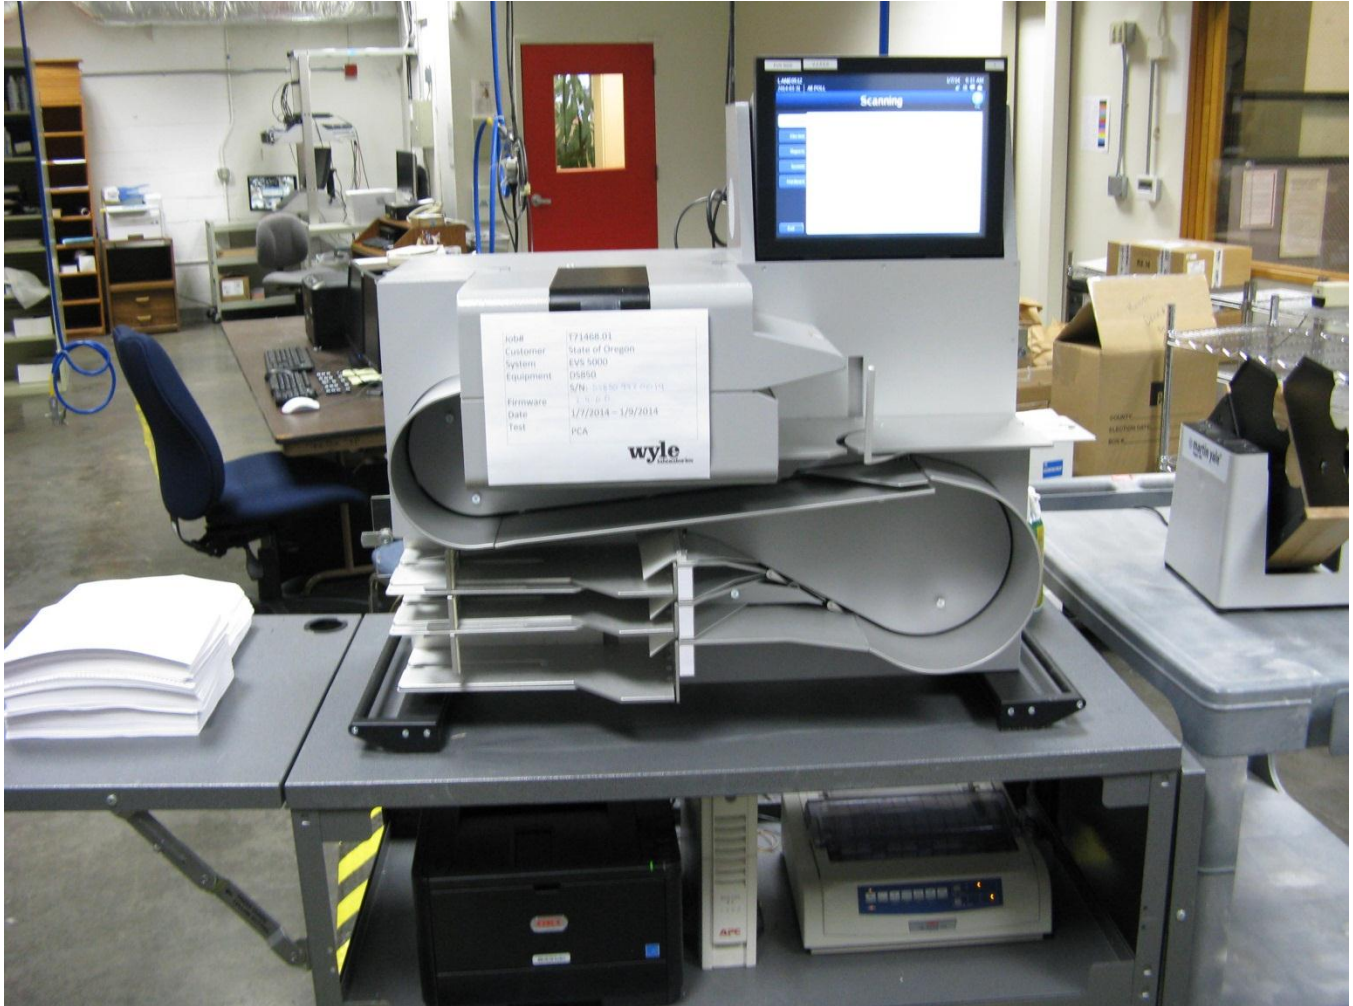
Photograph 1: DS8509420014-Machine 1

Photograph 2: DS8509420014-Machine 1

**Photograph 3: DS8509420014-Machine 1**

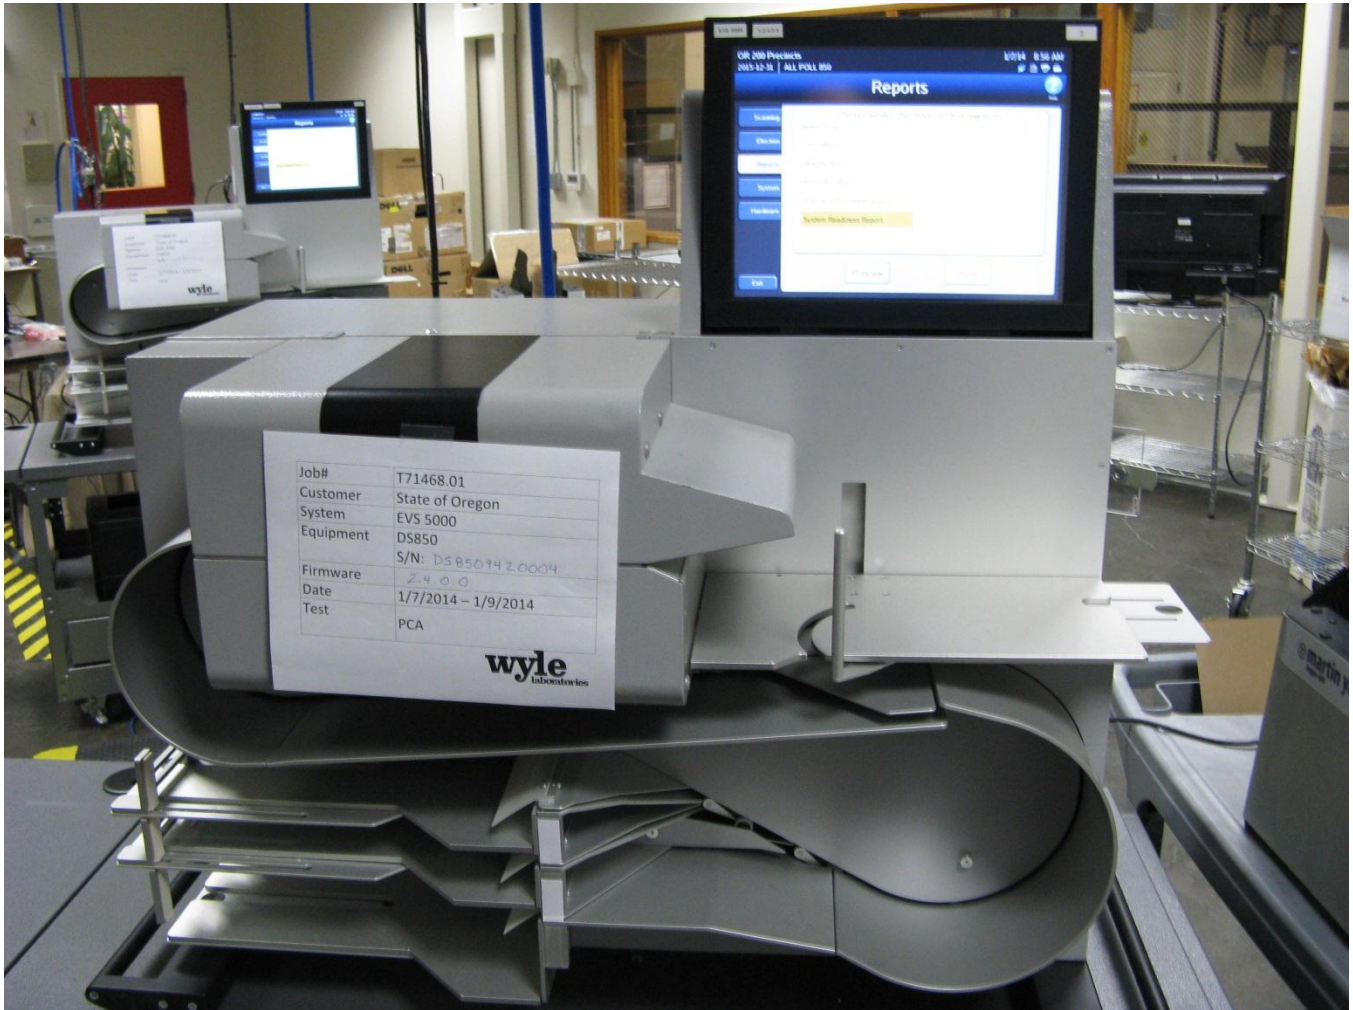
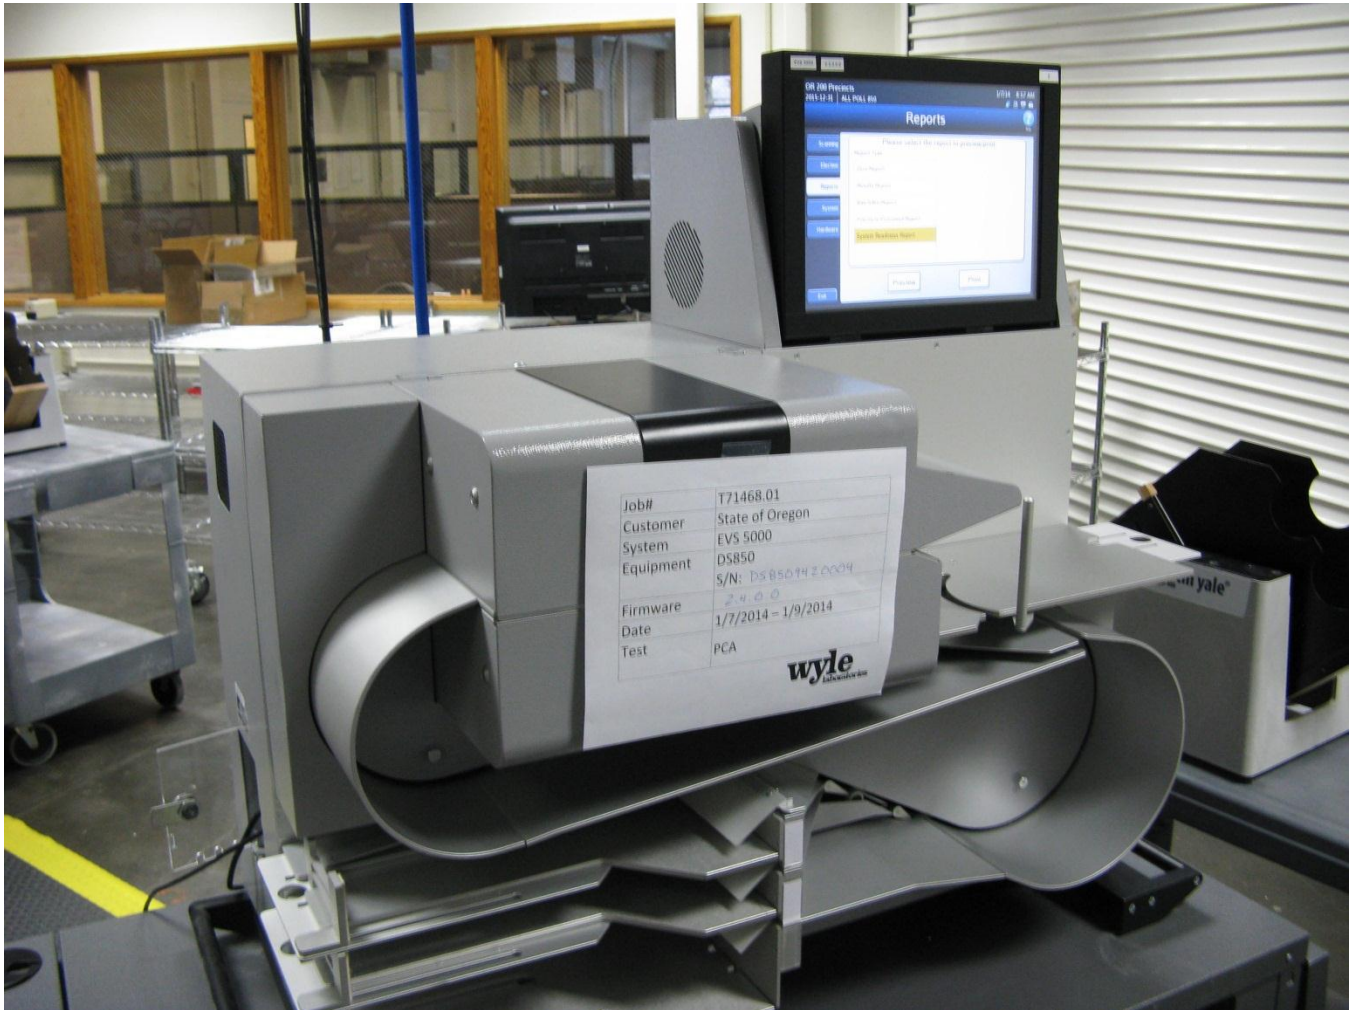
Photograph 4: DS8509420004-Machine 2

Photograph 5: DS8509420004-Machine 2

**Photograph 6: DS8509420004-Machine 2**

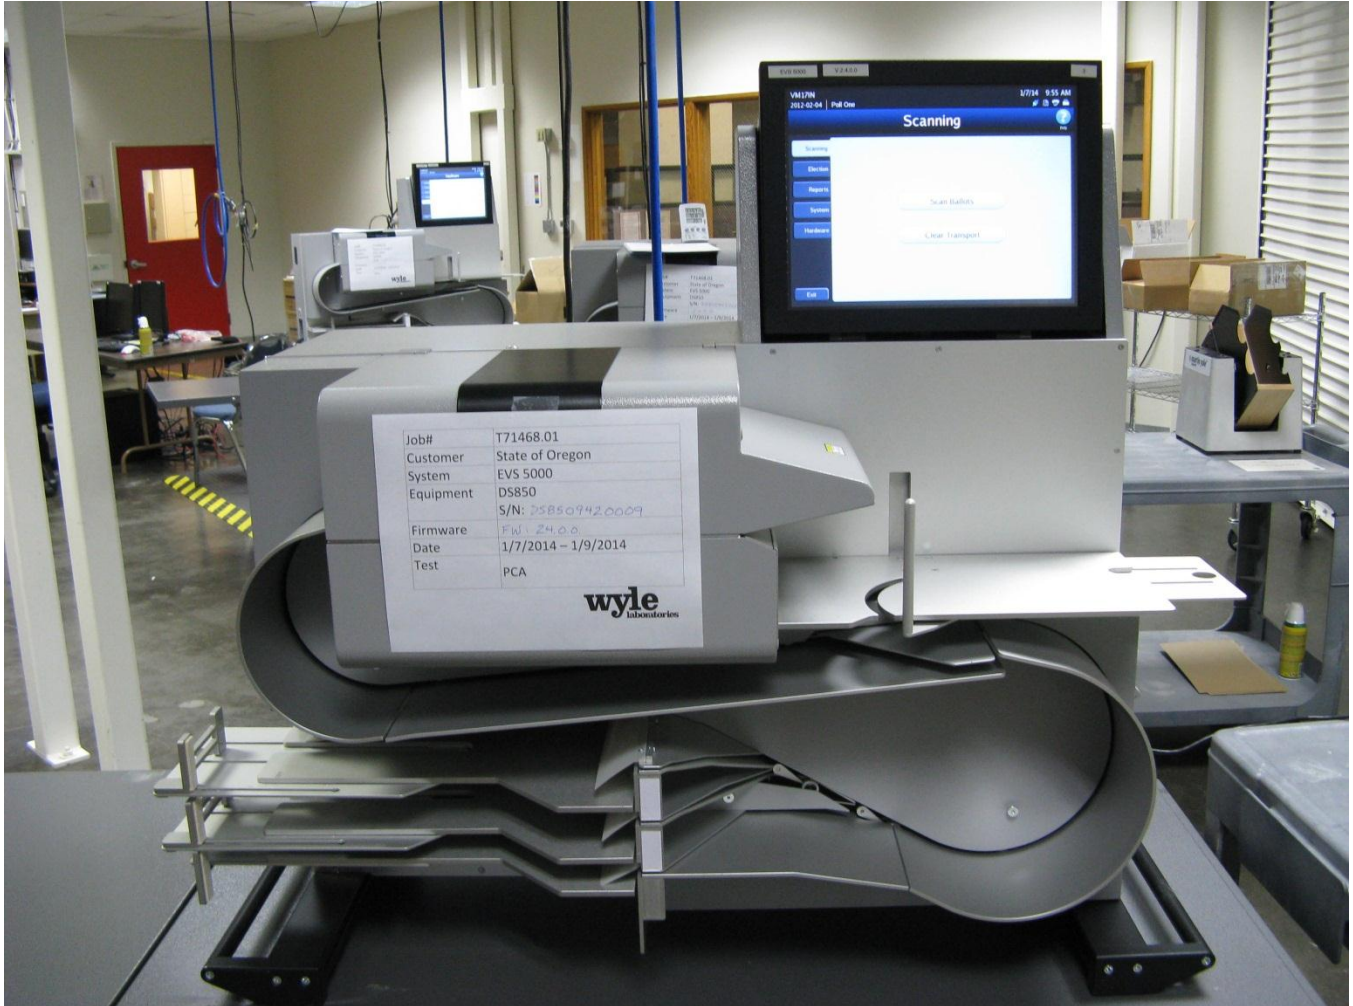
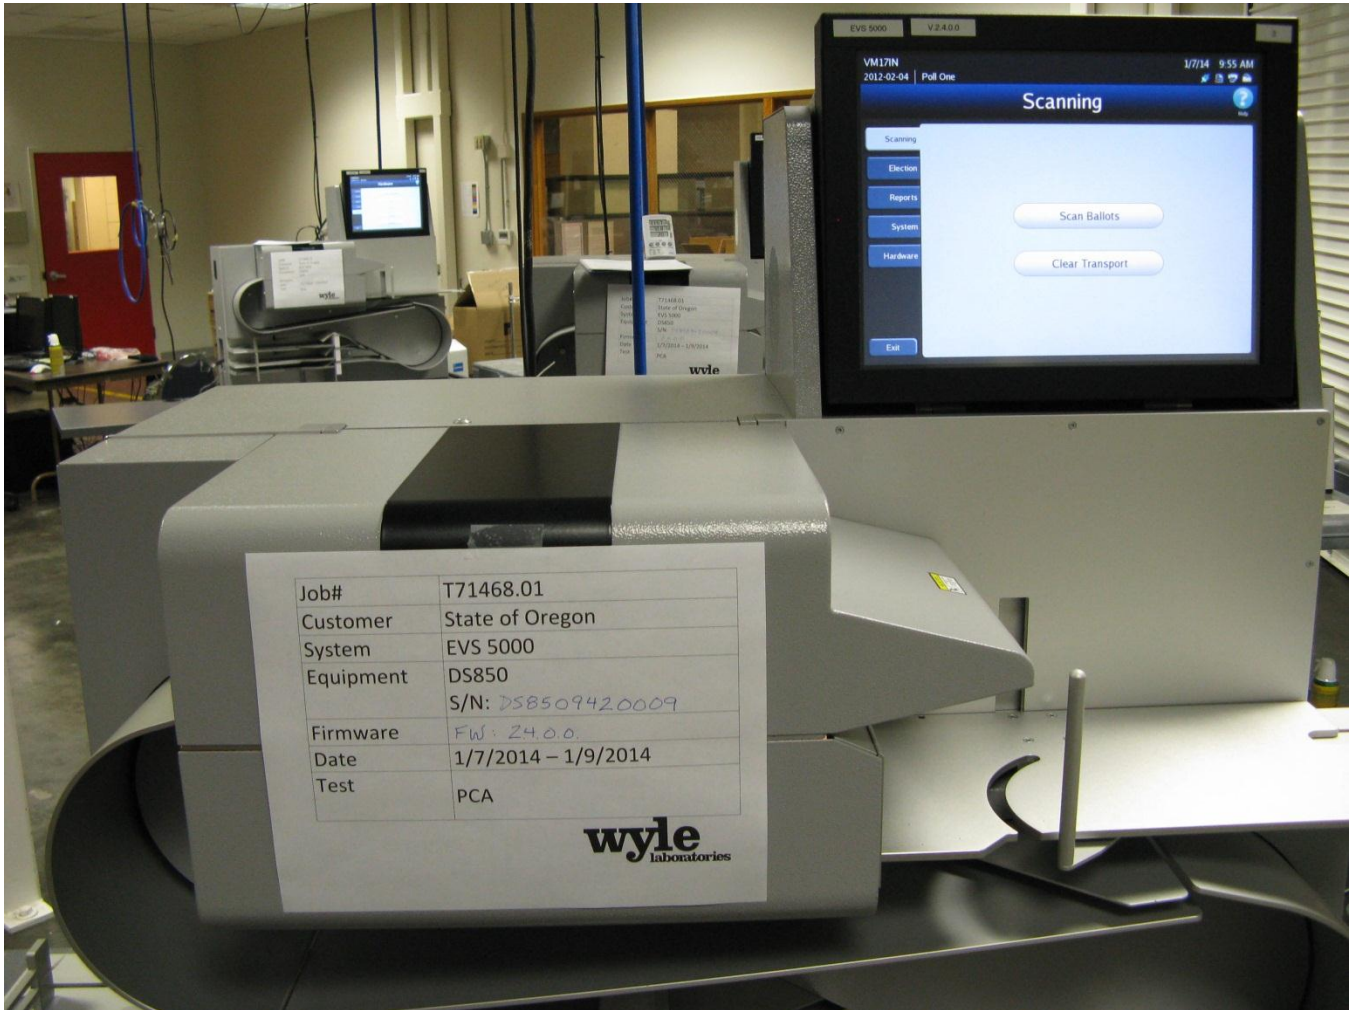
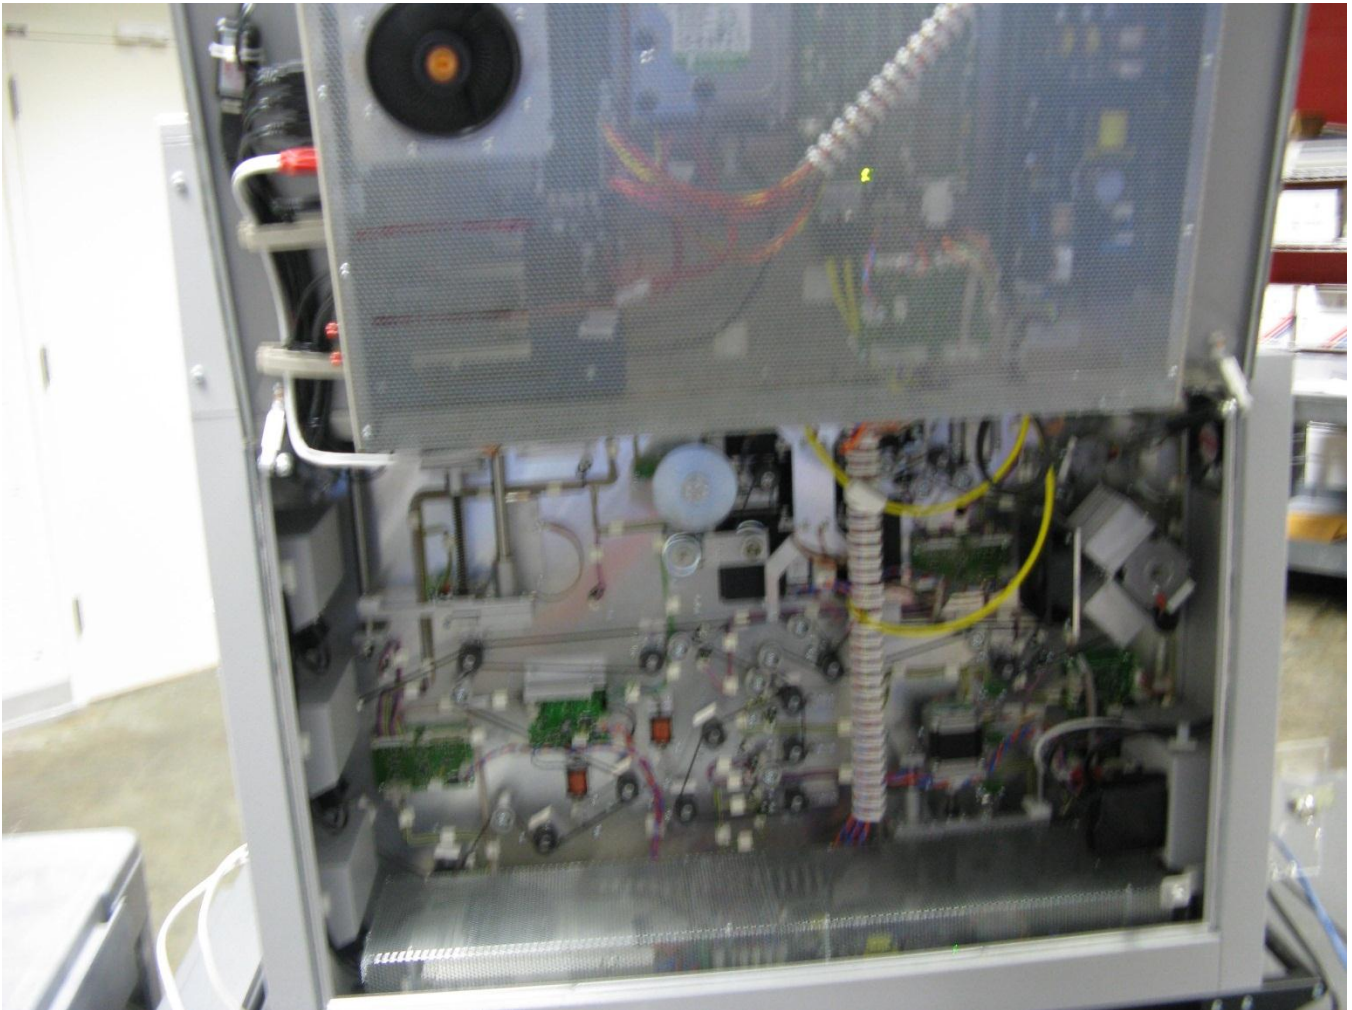
Photograph 7: DS8509420009-Machine 3

Photograph 8: DS8509420009-Machine 3

**Photograph 9: DS8509420009-Machine 3**

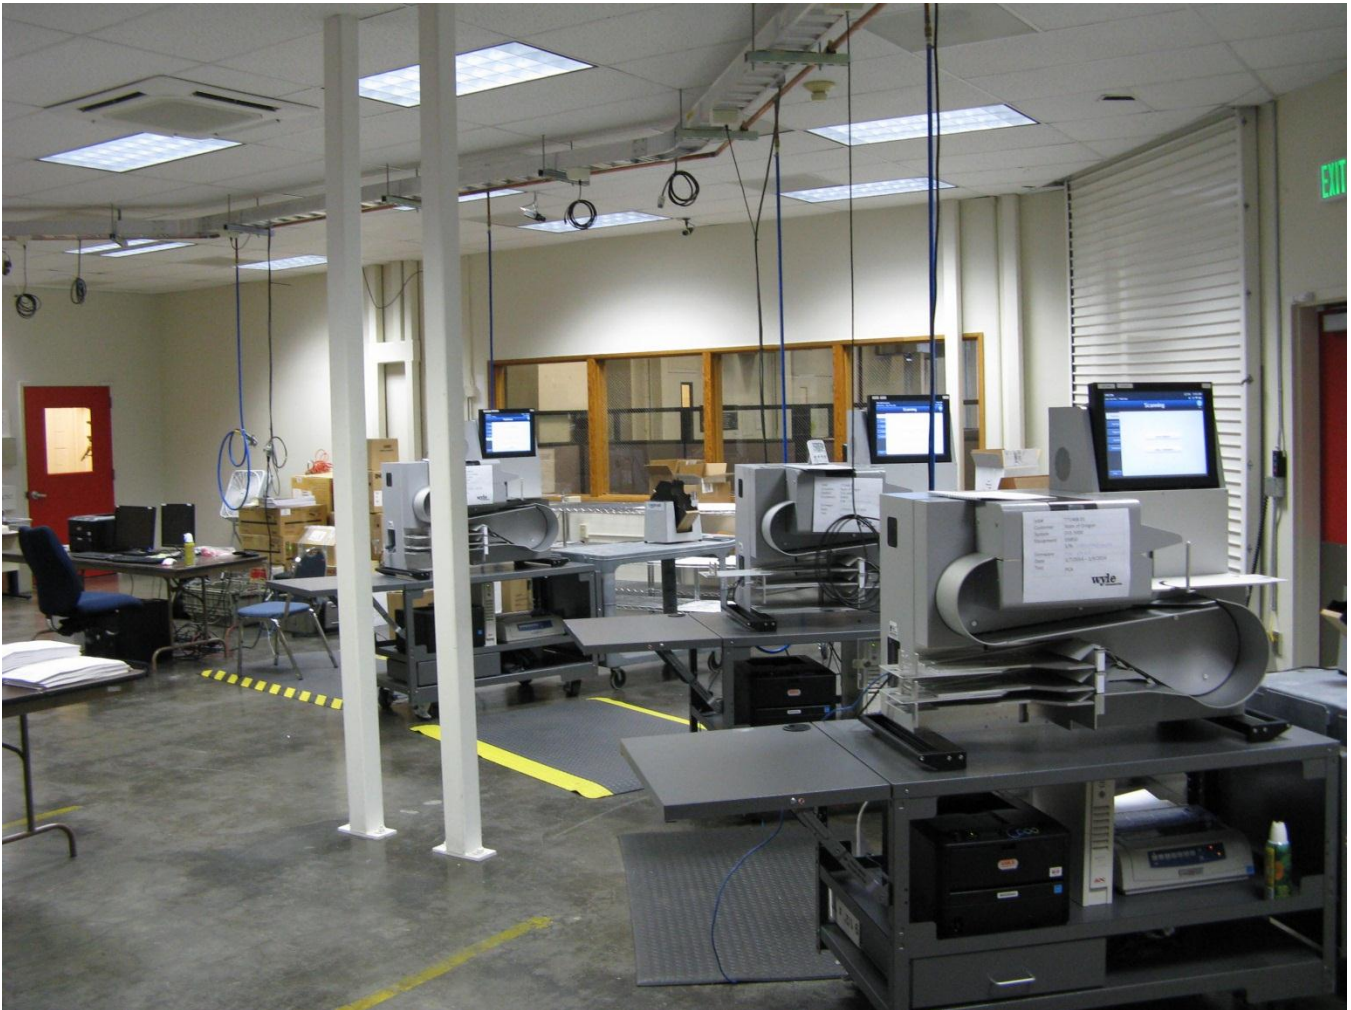
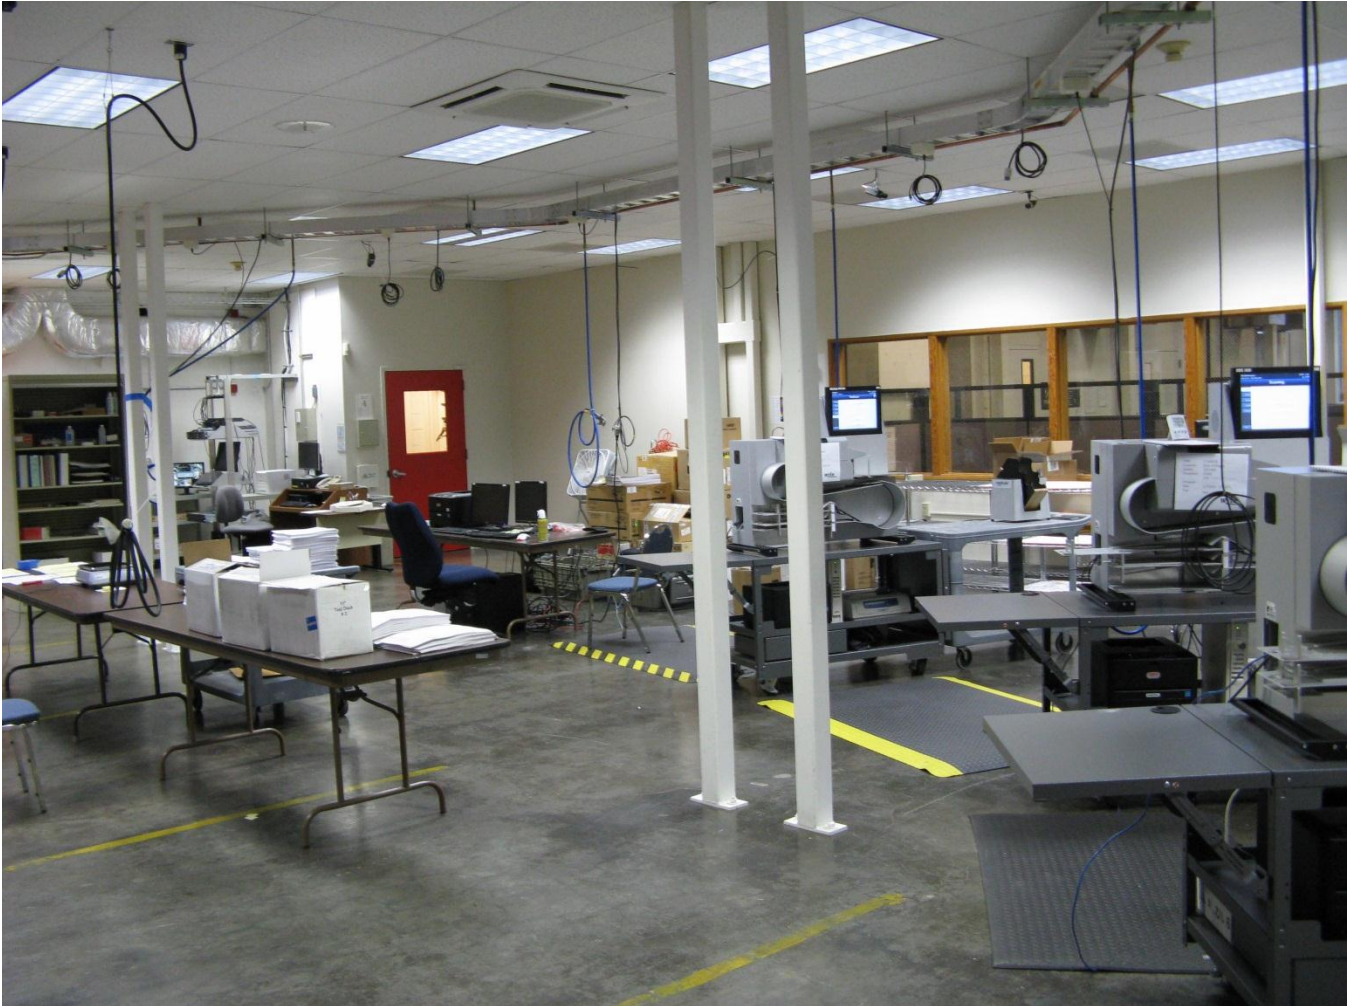
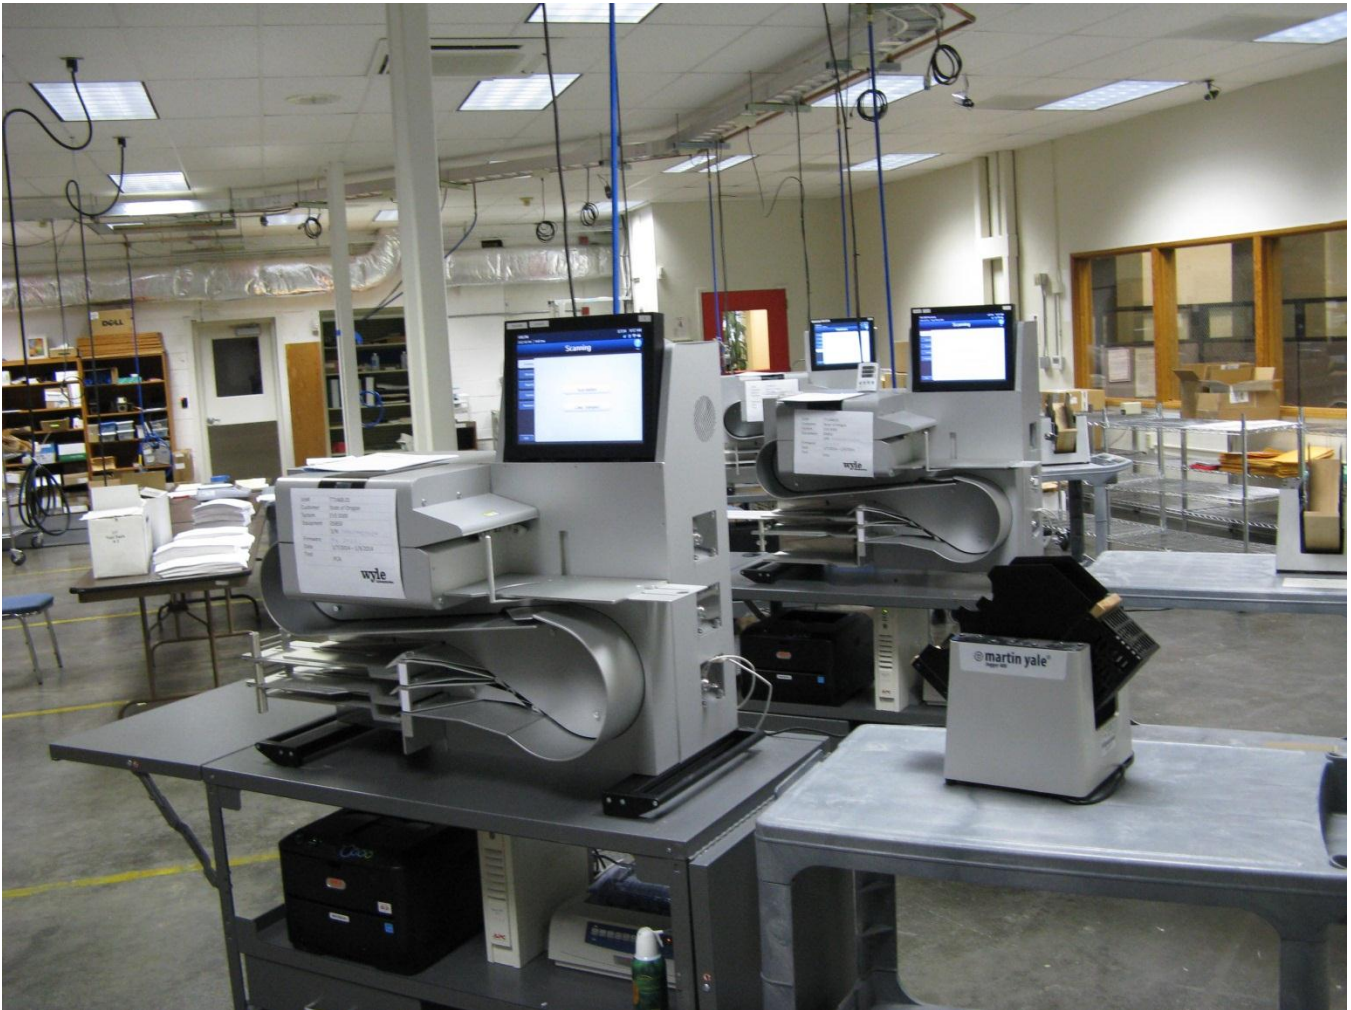
**Photograph 10: DS850 Testing Setup**

**Photograph 11: DS850 Testing Setup**

**Photograph 12: DS850 Testing Setup**
